# Manhole Inspection Summary

Manhole # S29G\_\_042MH

Insp Date: **4/1/09 1:55 PM**

**Location** Address: **BALTIMORE ST**

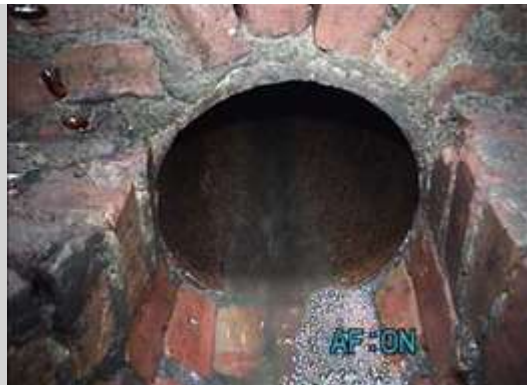
3 O'Clock Inflow

Pipe Height: **8.4** (in.) Rod and Bar (Angled)  
Pipe Material: **Clay** ☐ Pipe Lined  
Invert Depth: **12.02** (ft.) Flow Characteristics: **Slow**  
Deposits: ☒ None ☐ Mud ☐ Sludge ☐ Debris ☐ Grease  
Silt Depth: **0** (in.) Deposits Extent:  
Infiltration: **None** Pipe Seal Cond: **Sound**

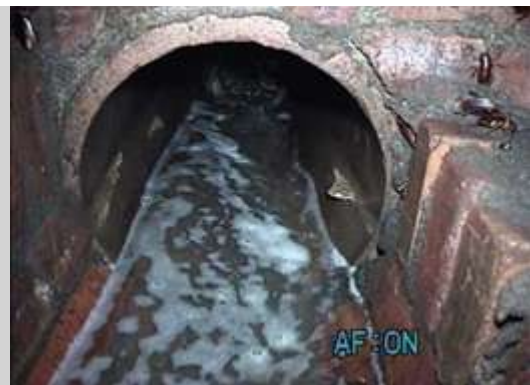
6 O'Clock Inflow

Pipe Height: **8.4** (in.) Rod and Bar (Angled)

Infiltration: **None** Pipe Seal Cond: **Sound**
